**Evaluation of Predicted and Actual Water Quality
Conditions at the Marlin Mine, Guatemala**

**Prepared by
E-Tech International**

August 2010

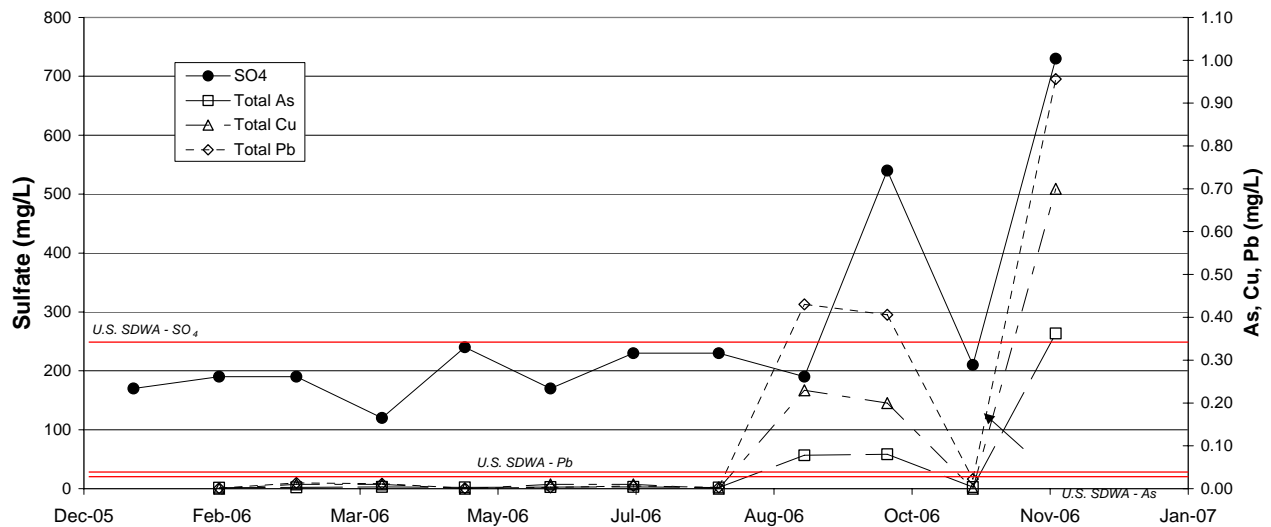
mg/l), chromium (up to 0.6 mg/l), iron (up to 737 mg/l total iron), manganese (up to 36.7 mg/l total manganese), nickel (up to 0.4 mg/l), silver (up to 0.263 mg/l), lead (up to 0.956 mg/l), vanadium (up to 1.32 mg/l), and zinc (up to 3.6 mg/l). Most of these concentrations exceed relevant drinking water or potable water standards by many times (see Table 2 for water quality standards). These standards are relevant because the groundwater in the underground mine could move to surface water or springs and be used for drinking water. A number of the contaminants of concern had markedly increasing concentrations at the middle and end of 2006, as shown in Figure 3 for sulfate, total arsenic, total copper, and total lead. Concentrations of sulfide were also elevated at the end of 2006 (increasing from below detection (<0.020 mg/l) in June to 31.8 mg/l in December). The presence of particulate metals and sulfide in the mine water suggests that solid metal sulfides from the ore may account for the observed increases. The pH of the mine water was above neutral in 2006, but changes in pH (higher or especially lower) could solubilize metals from the particulates and add to the more mobile dissolved metal load in groundwater or the tailings impoundment.

Figure 3. Concentrations of selected contaminants of concern in underground mine water (D1) in 2006.

Based on the water quality data for the underground mine water, the contaminants of concern include:

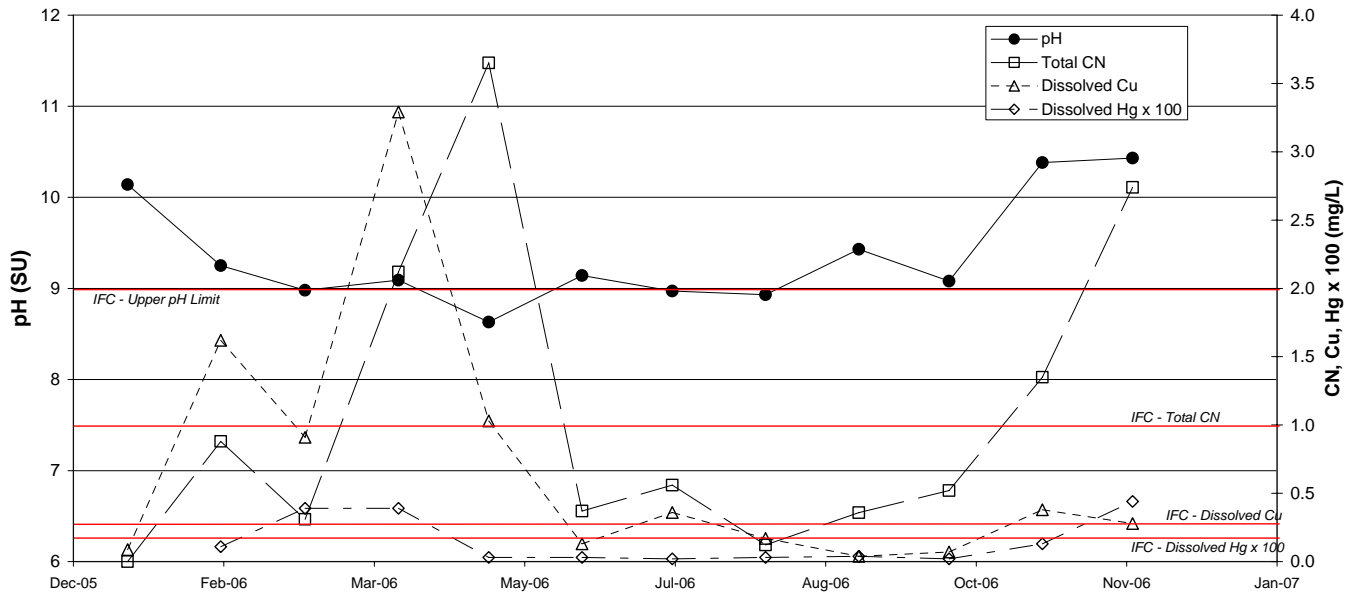
In 2006, sample D4 also had elevated concentrations of the same constituents and total dissolved solids (up to 2,960 mg/l), total cyanide (up to 3.65 mg/l), total aluminum (up to 2.87 mg/l), total iron (up to 1.6 mg/l), and mercury (up to 0.011 mg/l). Antimony concentrations were not elevated after Goldcorp switched to ACZ Laboratories from the onsite SGS laboratory. Sulfate concentrations were as high as 1,830 mg/l. Figure 4 shows the concentrations of selected COCs in tailings supernatant during 2006. Concentrations of total cyanide, dissolved copper, dissolved mercury, and pH values exceeded IFC discharge standards at different points in 2006. Maximum concentrations of cyanide, copper, and mercury were over three, ten, and 20 times higher than IFC standards.

Figure 4. Concentrations of cyanide (CN), dissolved copper (Cu), dissolved mercury (Hg), and pH in tailings supernatant water (D4), 2006.

Based on the water quality results for the tailings water, the contaminants of concern include:

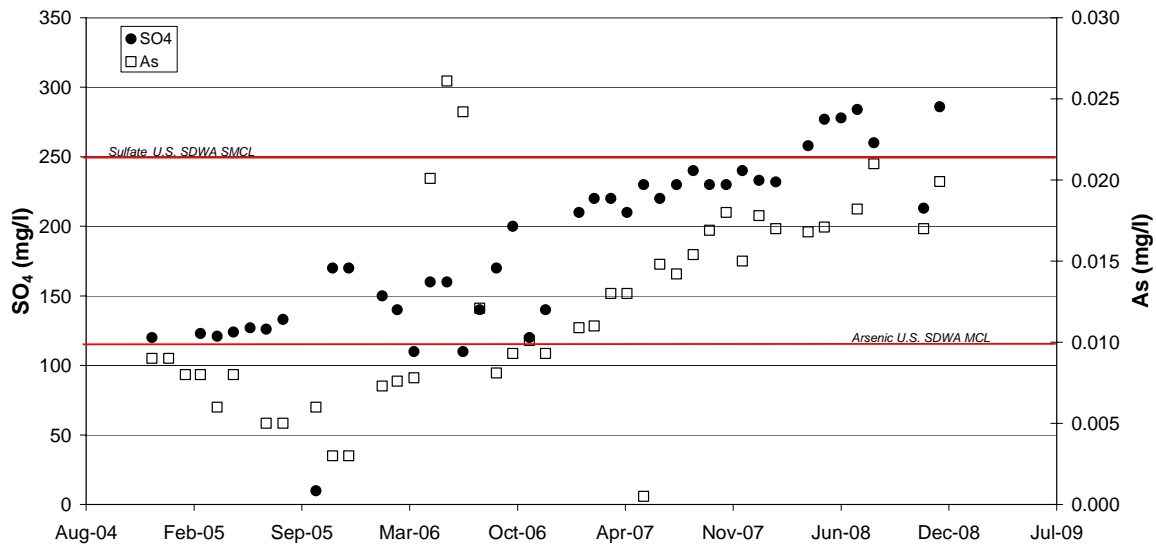
MW8, MW10, MW11. Monitoring well MW8 does not show elevated concentrations or increasing trends of any COCs. Monitoring wells MW10 and MW11, which were installed recently to upgrade groundwater monitoring downgradient of the tailings impoundment (Lisa Wade, Pers. Comm., email, Feb. 20, 2009) have elevated concentrations of arsenic. Concentrations of arsenic in MW10 range up to 261 µg/l, and in MW11 were as high as 46 µg/l. However, arsenic concentrations in well PW7, which is shallow and downgradient of the tailings impoundment, were not elevated (high of 6 µg/l). Arsenic concentration in the tailings supernatant water (D4) in 2006 were only as high as 38 µg/l, but pore water values in the tailings themselves have not been reported and could be higher or lower. Therefore, the source of the elevated arsenic concentrations in MW10 and MW11 is uncertain at this time. Sulfate concentrations are elevated in

Figure 5. Sulfate and dissolved arsenic concentrations in monitoring well MW5 over time.

MW10 (up to 450 mg/l) and are lower in MW11 (high of 70 mg/l). Sulfate concentrations are high in tailings impoundment water (up to 1,830 mg/l; 2006 AMR).

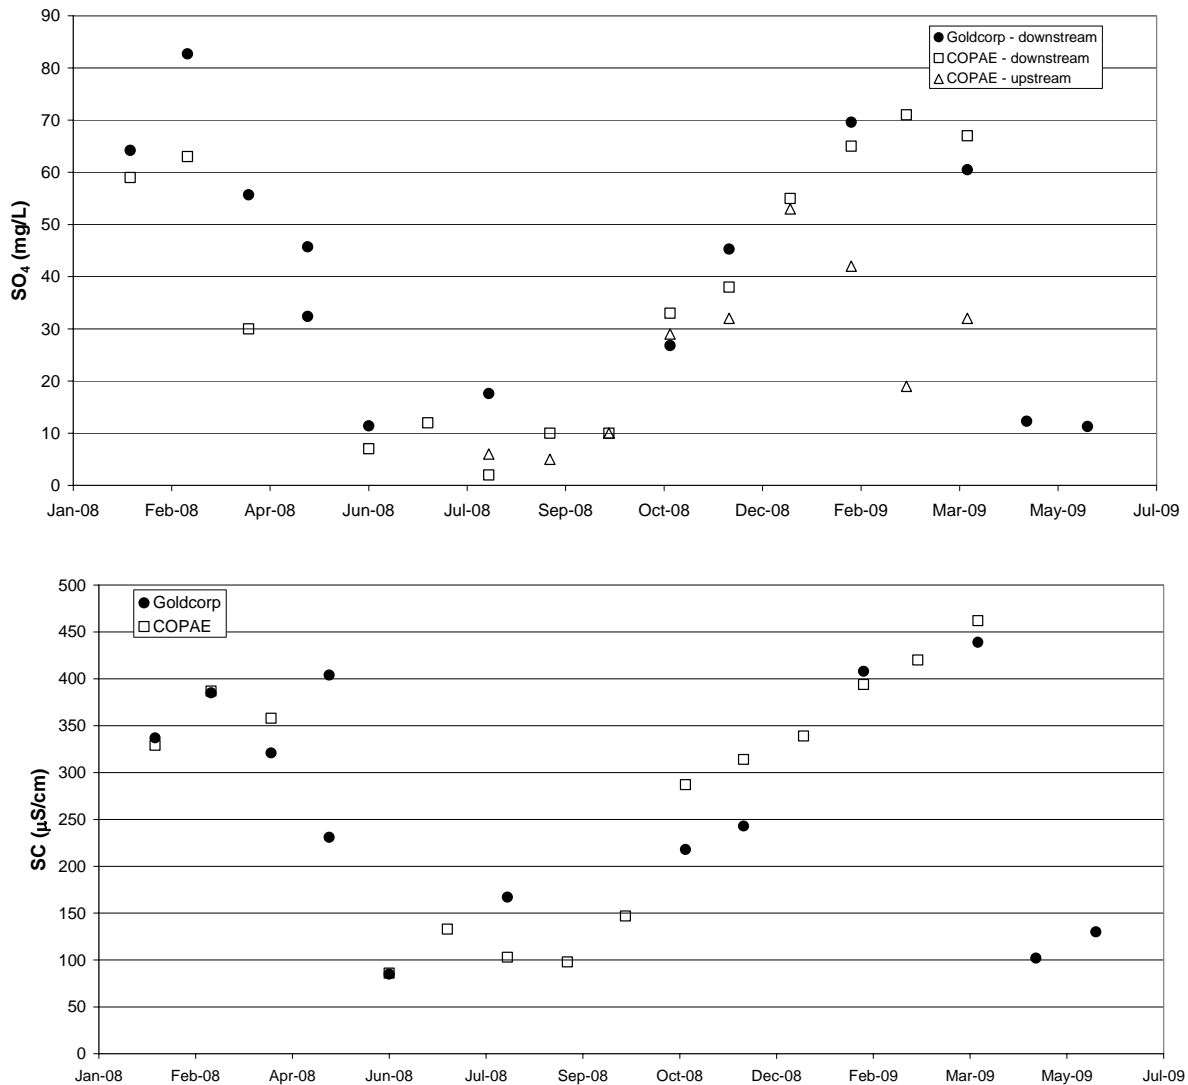
AMAC's total cyanide values for D6 in 2007 and 2008 are shown in Figure 8. The highest measured concentrations exceeded U.S. Clean Water Act aquatic life criterion values by over 12 times, and infiltration to groundwater from this source could adversely affect downgradient surface water. AMAC's results for D6 indicate that tailings seepage has elevated concentrations of sulfate, TDS, and cyanide. More information on the engineering of the tailings seepage pond and possible transport to the tailings tributary and Quebrada Seca should be investigated.

Figure 6. Comparison of Goldcorp and COPAE results for (a) sulfate concentrations in Riachuelo Quivichil upstream (SW6_C) and downstream (SW3 and SW2_C) of Quebrada Seca, and (b) specific conductance downstream of Quebrada Seca (SW3 and SW2_C).

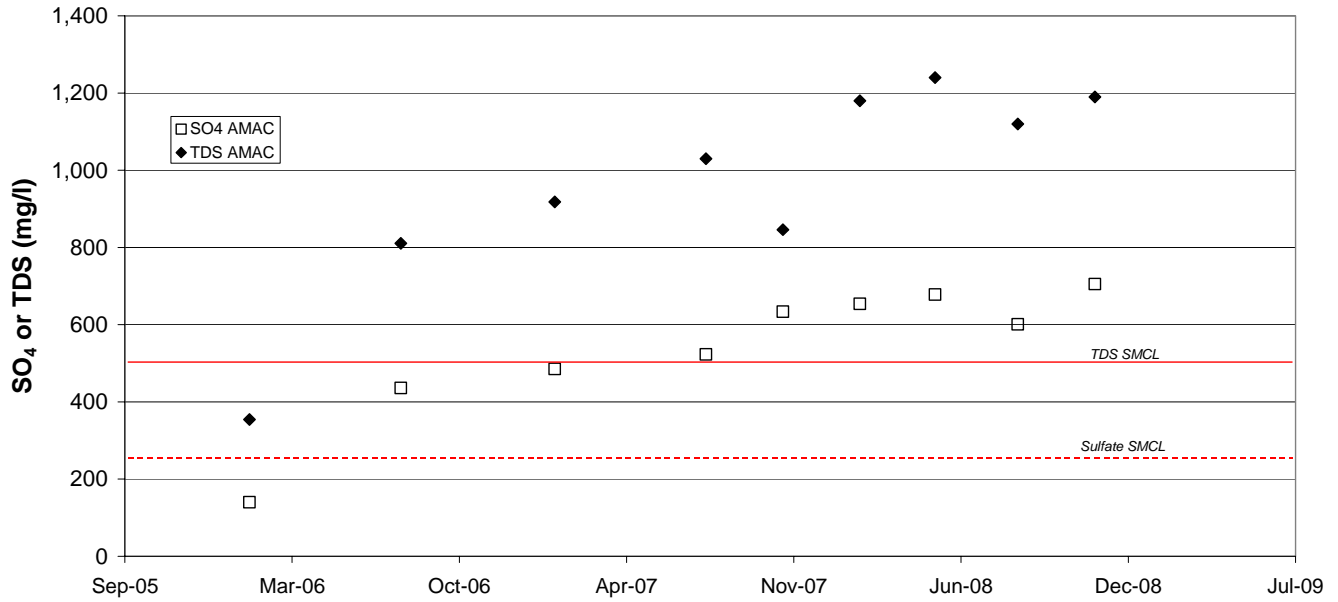
Figure 7. Sulfate and TDS values in tailings seepage pond below the dam (D6), AMAC data.

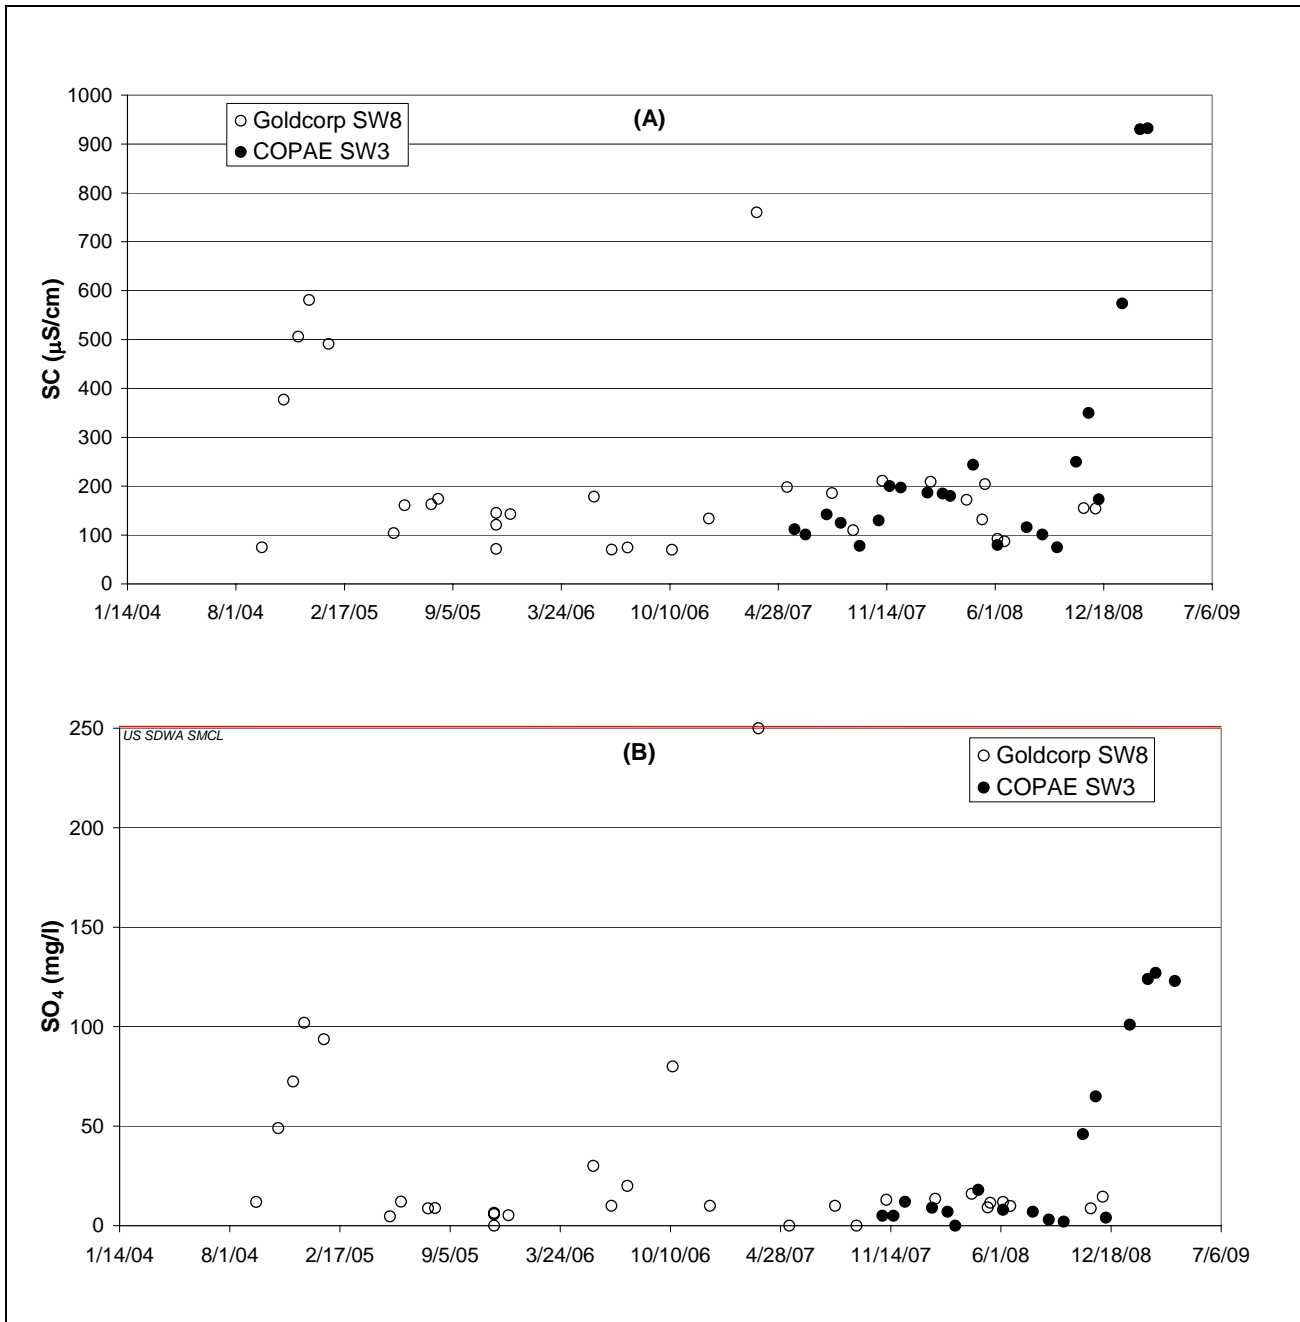
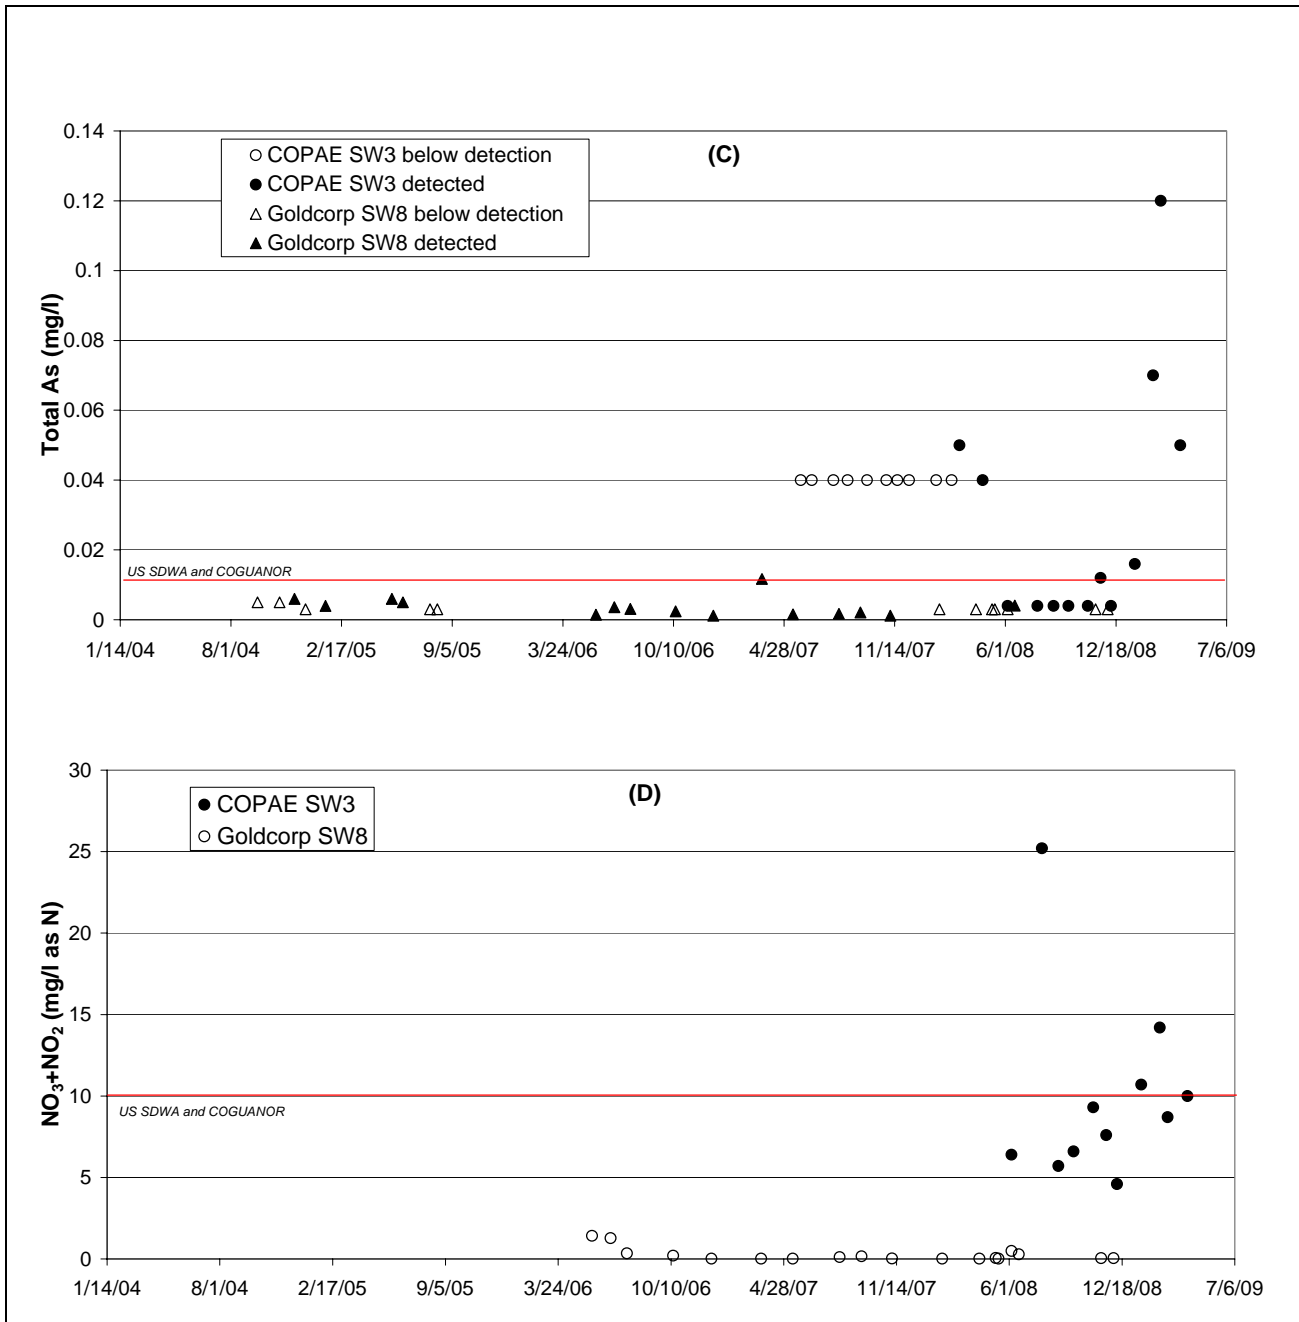
Goldcorp and COPAE sampled surface water station SW8/SW3_C, a non-perennial location in Quebrada Seca located downstream of the tailings dam and large waste rock pile (see Figure 2). Goldcorp's data showed occasional detections of total and WAD cyanide in October 2005 (0.40 mg/l), but concentrations were below detection (at 0.002 and 0.02 mg/l) in September and November of that year. No samples were collected during the dry season in 2006 (January through April), and cyanide was detected again in

Figure 9. Specific conductance (a), sulfate (b), arsenic (c), and nitrate (d) values in Quebrada Seca at SW8 and SW3_C.

Figure 9 (cont.). Specific conductance (a), sulfate (b), arsenic (c), and nitrate (d) values in Quebrada Seca.

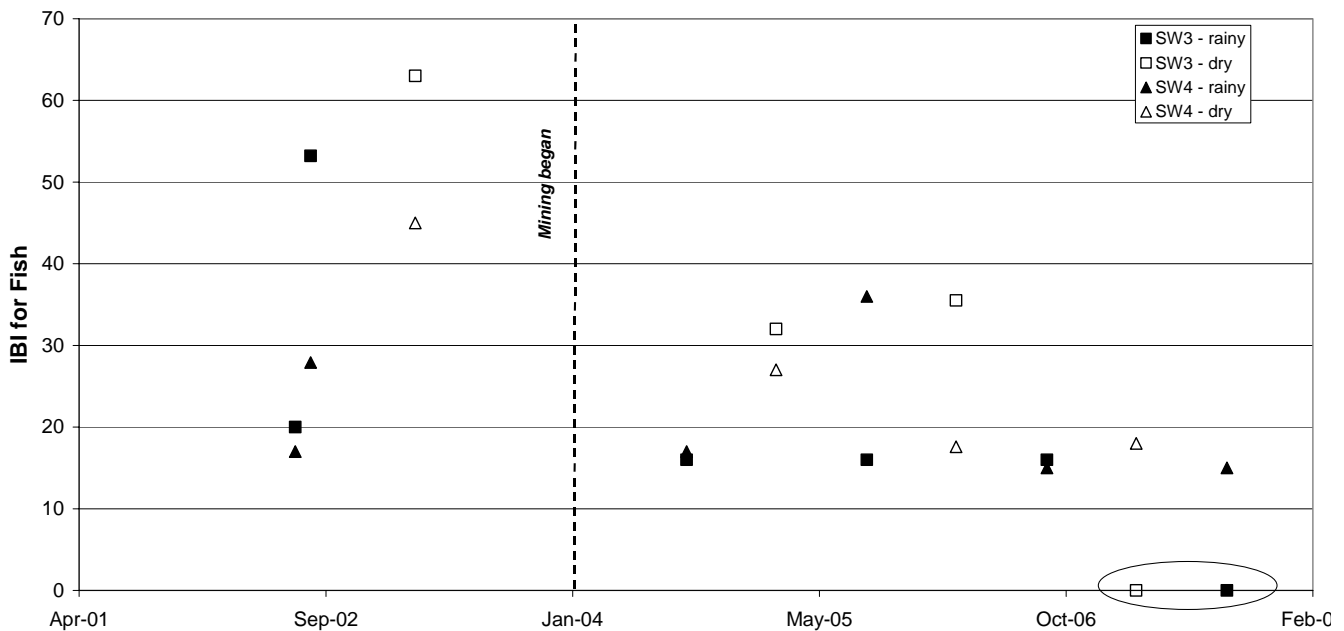
Figure 10. Index of Biotic Integrity (IBI) for fish at SW3 and SW4.

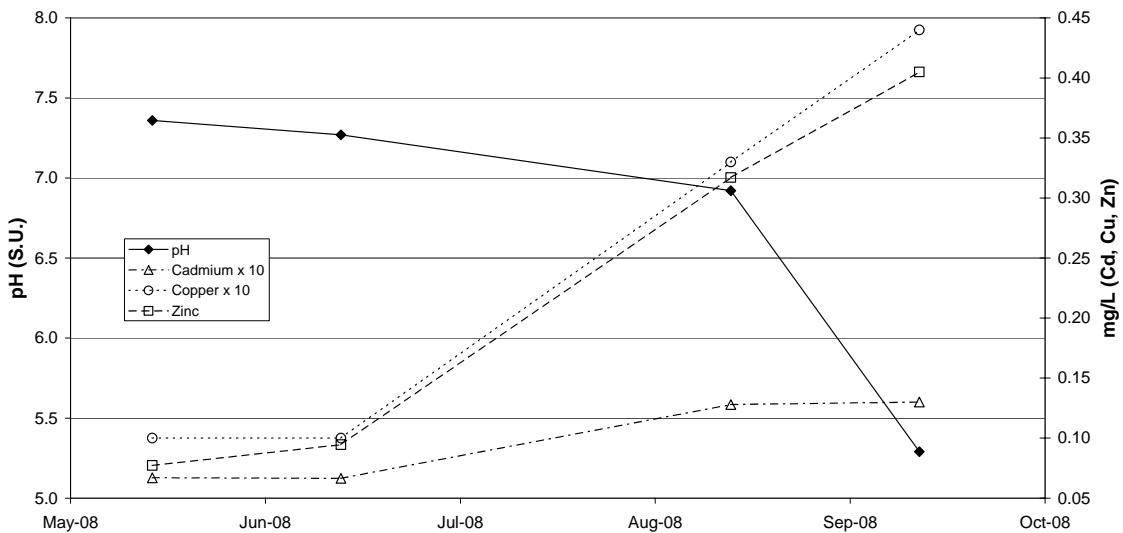
Figure 11. Decreasing pH and increasing metal concentrations in waste rock field sample 2188-29-126.
