## **E-Tech International Response to TGP**

March 25, 2006

### **Independent Audit and Repair Project**

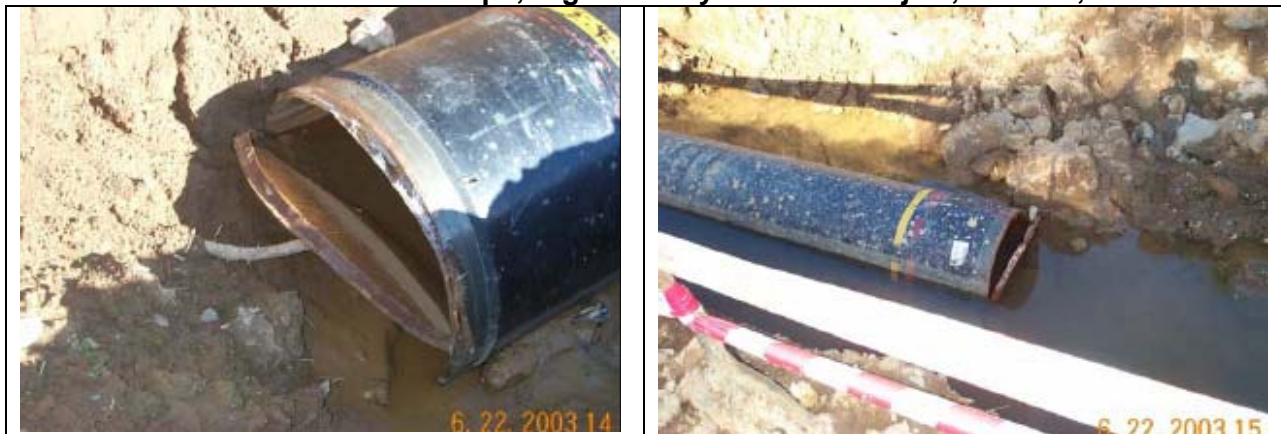
**Photos of 14-Inch NGL Pipe, Right-of-Way Camisea Project, June 22, 2003**

The ultimate arbiter of the history of each piece of pipe installed in the pipelines is the pipebook. The reality is that a significant part of this pipe arrived at the construction site without protection of the pipe tips and with internal corrosion. Nevertheless, the use of pipe left over from other projects, or the use of pipe that has been stored outdoors for a long period of time following fabrication without adequate protection, is not prohibited by

the applicable codes (ASME B31.4 and ASME B31.8). What is prohibited by these codes is the use of pipe with excessive internal corrosion. The outdoor exposure originated corrosion that resulted in pipe wall thickness less than the acceptable limits defined in the codes. Excessive internal corrosion is the fundamental problem. Whether the reason for this corrosion is that the pipe was left over from other projects, or was exposed to the elements for a long period without suitable internal protection at a Tenaris facility, is a subject of contractual significance only.

For example, TGP includes in Attachment 2 a certificate of authorization of shipment for 1,784 pieces of 14-inch pipe with a factory inspection date of January 28, 2002. Below are two photos of 14-inch pipe in the ROW of the Camisea Project taken on June 22, 2003. The pipe sections in the photos do not necessarily belong to the shipment authorization provided in Attachment 2. However, a year-and-a-half had passed since the date of the shipment authorization. As can be seen in the photos, the pipes are coated with a triple layer of polyethylene, as indicated by TGP. However the internal portion of the pipe is not protected in any way and both pipes are sitting in mud and water. The key issue is the lack of internal protection for a significant part of the pipe used in the project. This pipe had been exposed outdoors for a long period of time before arriving at the site. The fundamental technical issue is the degree of internal corrosion in the pipes that were installed, not who was the manufacturer or where these tubes were stored before arriving at the site.
