October 20, 2007

**Subject: IDB Auditor Exponent, Inc. Identification of Design Deficiencies in Construction of Camisea I Pipelines and Need for Monitoring That Is Independent of IDB**

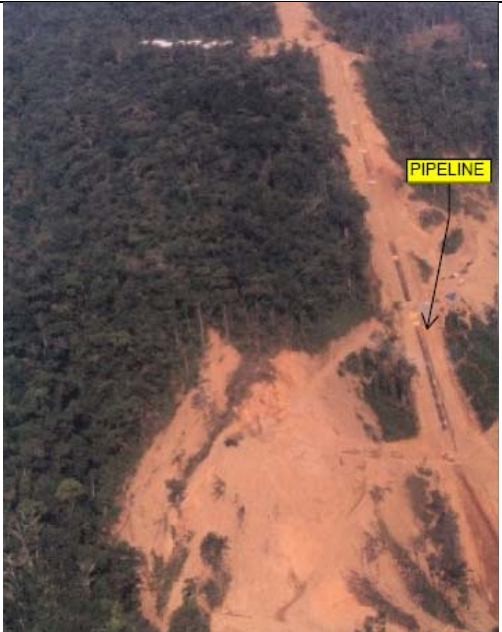
Observation by Exponent	Issue and Supporting Information	Photographs
<p>To minimize environmental impact, the constructor decided to preferentially build the pipeline along mountain ridges. The right-of-way (ROW) was cleared and cut, and the work was inspected by outside consultants.</p> <p>The ground conditions encountered during installation of the pipe were reportedly assessed by geotechnical engineers and some mitigation measures were constructed at that time.</p>	<p><b>The lack of detailed assessments of geotechnical conditions along proposed route in jungle sector prior to opening right-of-way and beginning construction unnecessarily created geotechnical risk (soil movement, landslides).</b></p> <p>OSINERG president Alfredo Dammert testimony:* <i>“The concession holder (TGP) is responsible for establishing the pipeline route.”</i></p> <p>TGP representative Mario Dell’Acqua testimony:* <i>“We were the first to enter this jungle. All other studies were studies via helicopter overflights. But you can see that despite this we opened the right-of-way, excavated the trench, and set the pipeline in place in our first attempt”.</i></p> <p>TGP geotechnical consultant Golder Associates, testimony of Sigfried Arce Helberg:* <i>“Golder spent 36 days in the field in October and November 2001 conducting a rushed preliminary route survey across nearly 200 kilometers of largely uncharted jungle terrain. Critical zones that required route changes were identified and flagged for further study.”</i></p> <p>(*) Transcript of testimony given to Peruvian congressional committee investigating Camisea pipeline ruptures, June 2007.</p>

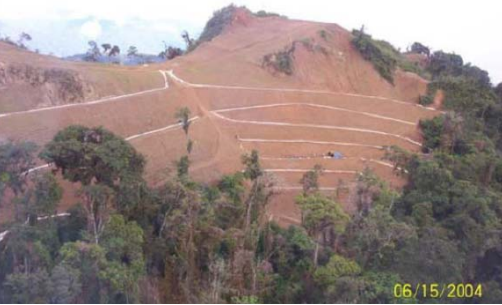
<p>Exponent observed over 50 sites, some on both occasions, during our field inspections in June and September 2006. Based on our review, observations, and engineering experience, we concluded that geotechnical and geologic conditions initially posed a substantial risk to the pipeline.</p>	<p><b>The lack of adequate geotechnical and erosion control along route during the construction phase represents an ongoing risk to the integrity of the pipelines.</b></p> <p>IDB consultant URS documented severe erosion control problems in its monthly field reports in 2002-2003, stating TGP was consistently violating its own erosion control technical specifications and appeared exclusively concerned with <i>“advancing the laying of pipe.”</i></p> <p>USAID recommended in a July 2003 memorandum to the U.S. Treasury against the U.S. Government voting for the \$75 million IDB loan to TGP in part because of erosion control problems observed in the pipeline right-of-way.</p>

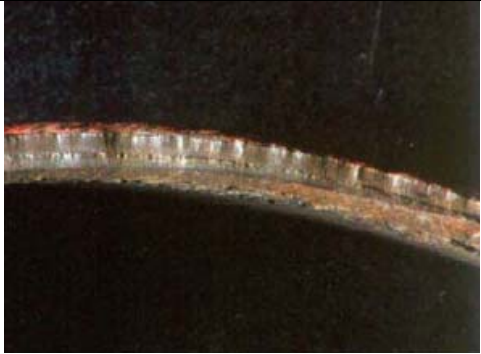
Observation by Exponent	Issue and Supporting Information	Photographs
<p>Our design review revealed that the pipeline designers assumed that external soil loading would be entirely mitigated by geotechnical mitigation measures implemented during construction. Load capacity estimates for the liquids pipeline show that, while sufficient for internal pressures, it is susceptible to this external failure mode, which is consistent with four of the first five spill incidents. Natural gas pipeline is more robust and has 6x the capacity to resist external loads.</p>	<p><b>The thin pipe wall of the liquids pipeline makes this pipe susceptible to damage/ rupture caused by soil movement.</b></p> <p>Photo: cross-section of 5.56 mm (0.219 inch) liquids pipeline at point of 1<sup>st</sup> rupture at km. 8.8 (photo from Exponent report).</p>

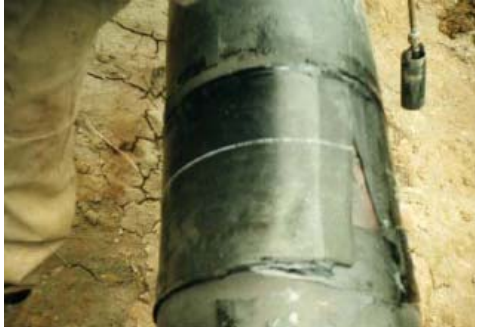
<p>There is accelerated corrosion in certain sections of the liquids pipeline, especially in the first 50 km. This corrosion weakens the pipe. The 2006 intelligent pig inspection revealed a point in the jungle sector that had lost 49% of its nominal wall thickness to corrosion. Approximately 20% of the corroded sites detected during the internal inspection had lost between 10 and 25% of nominal wall thickness, the remaining ~80% less than 10%.</p>	<p><b>There is an accelerated rate of corrosion in the liquids pipeline in the jungle sector.</b></p> <p>The TGP technical specification used on the project required the replacement of any pipe sections that had lost more than 10% of their nominal (design) thickness at the time of installation.</p> <p>The international standard referenced by Exponent, DOT 49 CFR 195.542, stipulates that repairs must be carried-out within six months if pipe has lost 50 percent of design wall thickness.</p> <p>Polyguard, the U.S. manufacturer of pipe joint seals, wrote a Sept. 17, 2007 letter to the MEM Minister Valdivia clarifying that Polyguard seals were not used in the jungle sector on the liquids pipeline, and questioning whether the cathodic protection on the pipeline was serving the intended purpose. The letter references the Exponent audit. The September 17, 2007 Polyguard letter is attached.</p> <p>Photo: liquids pipeline joint seal with poor adherence - jungle sector.</p>

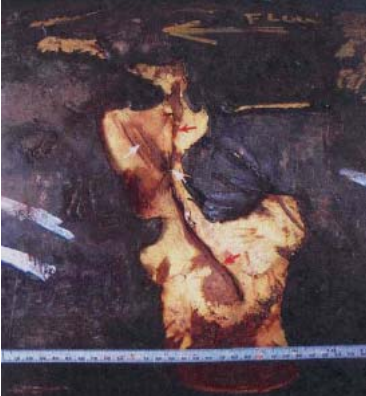
<p>TGP partially followed an international standard (FHWA HEC-18) in determined the depth of burial of the pipe under streambeds.</p>	<p><b>Failure to perform site-specific analysis based on actual conditions at each stream and river crossing has increased danger of exposed pipe and impact ruptures.</b></p> <p>TGP relied on a computer model to determine depth of burial for the pipelines. The lack of site-specific analysis to corroborate that the calculated burial depth was sufficient at each crossing creates the potential for more impact ruptures of pipe placed under streambeds. There are 62 stream and river crossings along the route.</p> <p>Photo: picture of 4<sup>th</sup> rupture, caused by rock impact in steambed, occurred Nov. 24, 2005 (photo from Exponent report).</p>
